The importance of preventive maintenance on steel reinforced concrete structures to impart sustainable development.

Key words: reinforced concrete, preventive maintenance, service-life.

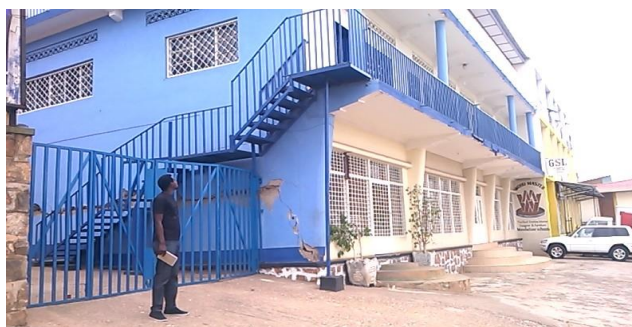
Fig.4a and 4b shows the pictures of one of identified buildings affected by corrosion of steel reinforcement.

Despite the claims of new discoveries of concrete materials and advancement in concrete technology, the fact remains that the present structural health (performance and durability) of concrete structures is a real set back. The structures shown in Fig.4a and Fig.4b were conditionally assessed and found with the state of reinforcement corrosion after 8 years and 25 years in service respectively. In large reinforced concrete structures, different members or parts of the same structure are exposed to different environments, so they may be attacked by corrosive agents differently hence the extent of corrosion damage would be different. The work objective was to investigate the causes of deterioration to the reinforced concrete structures of building-A and building-B and suggest the remedial solutions.

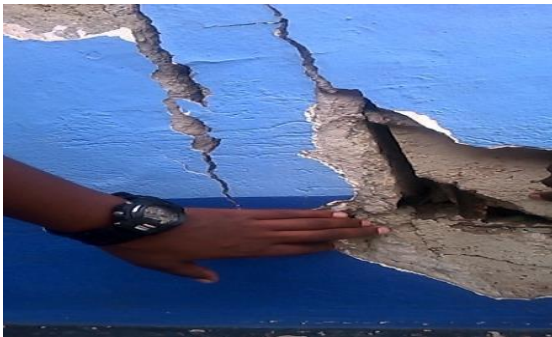
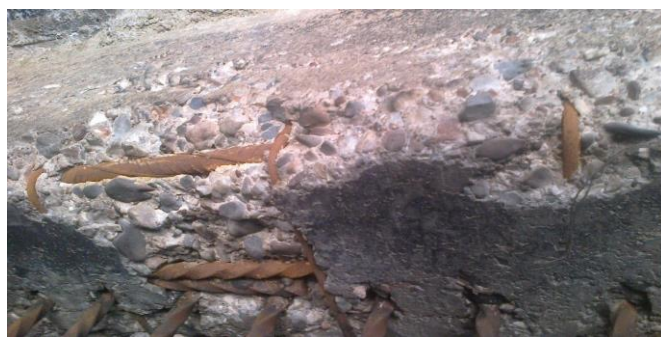
Fig.5a and Fig.5b are photos of corroded members on building-B (Photos taken during the survey in Kigali city)

It is needless to say that corrosion of reinforcement is active on concrete structural members of Fig.5a and Fig.5b. Neither has protective maintenance nor repair has been considered of importance than collective maintenance with such case of structural health conditions. It is reasonable to comment that sometimes protective maintenance on reinforced concrete structures is overlooked or neglected and it ends into irreversible state of reinforcement corrosion for reinforced concrete structures.

- For Building-B, it was due to aging of the concrete and less grade and insufficient cover concrete that resulted into carbonation. This cause spalling and delamination concrete deteriorated and finally corrosion of reinforcement reached irreversible stage.

- Finally building-A was found reparable. However, spalling rate of concrete in building-B is very high since reinforcement are exposed as seen in Fig.5a and Fig.5b hence, it is necessitates reconstruction.
